### Auburn Islamic Center - Pavilion Slab

### **Project Description**

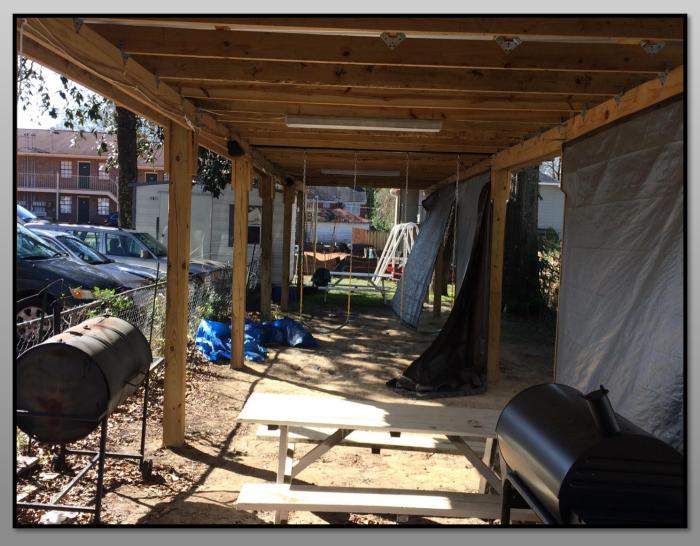
- The Auburn Islamic Center has a wooden pavilion covering an area for recreation. This pavilion provides a spot for children to play or for adults to cookout and enjoy the outdoors.
- This structure is supported by 6"x6" posts and has a metal roof. There was no floor system in place, making the area less desirable to use.

Our group was given the opportunity to design a concrete slab for this pavilion. The slab now covers everything underneath the structure. This provides the users with a clean, durable surface to enjoy for years to come.

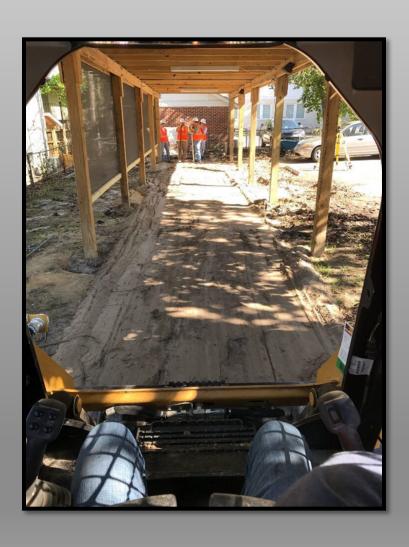
- The first change to our original design was the application of a sand sub-base.
- After the initial ground breaking, we discovered that the existing soil conditions were suitable.

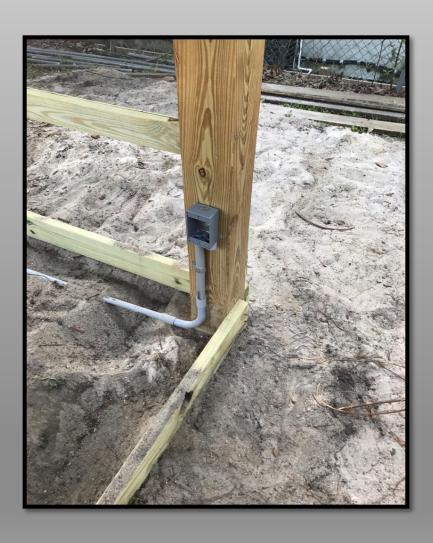
- Another change to the design was the slab dimensions.
- The slab edge was brought in flush with the columns.
- The pavilion is to be formed up and enclosed in the future.

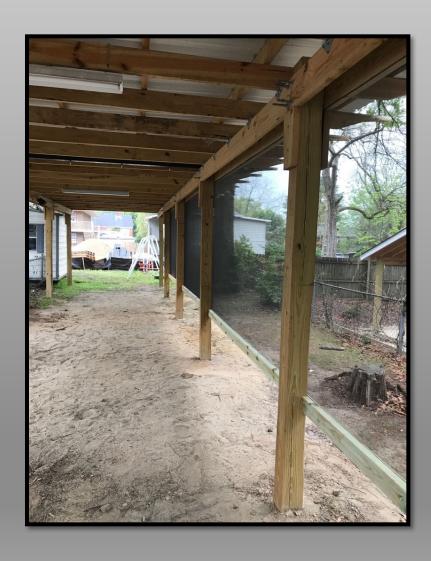
An initial challenge that our group encountered was the application of a screen wall.

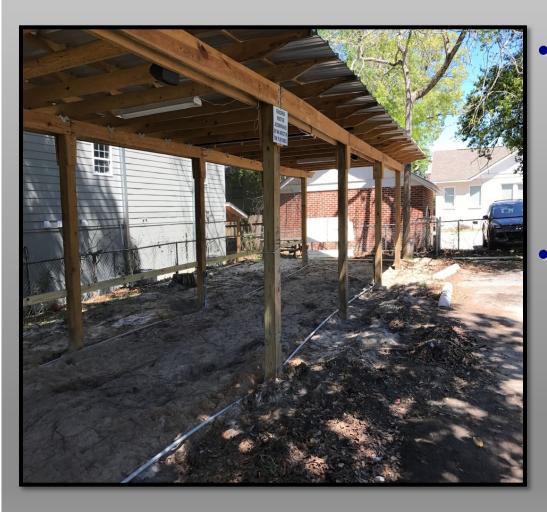
- The final challenge encountered was the early installation of electrical conduit.
- Our group had not finished grading and digging the turndown when the subcontractor arrived.

- The lessons our group learned mainly revolved around effective and consistent communication.
- Project conditions often change, so constant communication is crucial to success.
- The challenges encountered from the electrical conduit were due to ineffective scheduling with the electrical subcontractor.
